## **NICKLE PLATE ABANDONED MINE POOL “BLOWOUT” WASHINGTON & ALLEGHENY COUNTIES, PENNSYLVANIA<sub>1</sub>**

**Abstract.** On 01/25/05, a 10,000-gpm “blowout” of the century-old Nickle Plate Mine (Pittsburgh coalbed) occurred in a public sidewalk in McDonald, PA. The US Office of Surface Mining, first responder, installed diesel pumps and drain lines along public streets to control and convey the discharge to a nearby stream. On 02/22/05, the Pennsylvania Department of Environmental Protection, Bureau of Abandoned Mine Reclamation issued a 90-day emergency contract to Environmentally Innovative Solutions, LLC to provide a permanent control. With numerous partners (federal, state, local agencies; local residents and businesses), property access and historical data were acquired, piezometers and test pits were installed, and mine pool response tests were conducted. After data evaluation, the mine pool was manipulated to discharge ½-mile northeast of the “blowout” on undeveloped land. By 05/20/05, a primary gravity drain, alternate drain, and continuous monitor at the “blowout” had been completed. Subsequent monitoring confirms the facilities are functioning as designed.

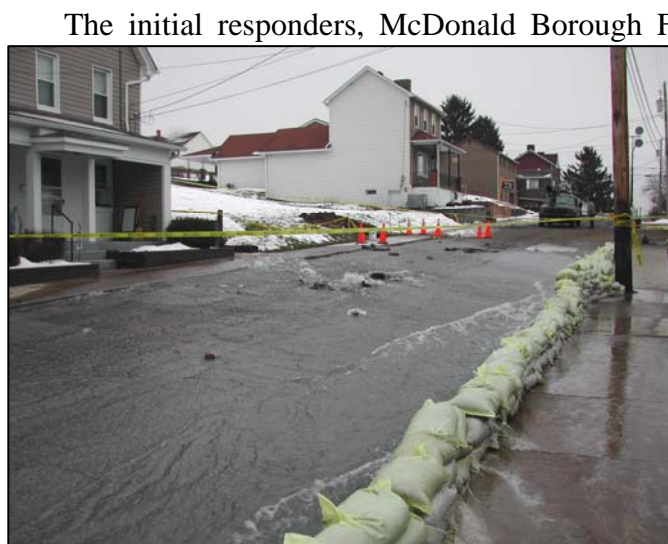
At approximately 2:00 pm (EST) on 01/25/05, while utility workers were using hand-tools to determine if a water main leak was responsible for drainage along a public road, a catastrophic “blowout” of an abandoned mine pool in the Nickle Plate Mine occurred. The confined conditions of the mine pool created a “geyser” with an estimated flow rate of 10,000 gpm. The “blowout” location was at 135 Liberty Street, along the sidewalk, in McDonald Borough, Washington County, PA, just 20 miles south of Pittsburgh, PA.

The Nickle Plate Mine (ca. 1890s thru 1930s) in the Pittsburgh coalbed (Pittsburgh Fm., Monongahela Gp.) underlies more than a thousand acres and, based on interpretation of available underground mine mapping, is interconnected with upgradient abandoned underground and surface mines. At the “blowout”, the downdip mine workings, enlarged by roof collapse, were less than 10 feet below the ground surface.

Figure 1. "Blowout" of the abandoned Nickle Plate Mine pool. Note flooding of Liberty Street, McDonald, PA. (01/25/05)

Through the efforts of OSM, by 3:30 am (EST) on 1/26/05, an 8-inch and a 12-inch pump, both with about 1000 feet of discharge hose, had been installed to convey the degraded mine drainage to the nearest watercourse, Robinson Run, of adequate size. (Upstream of the discharge hose, Robinson Run, with total iron and aluminum content generally exceeding 40 mg/l and 20 mg/l, respectively, was devoid of aquatic life.) By 2/15/05, the 12-inch pump was removed as the estimated flow rate had decreased to ~4,000 gpm. By 2/18/05, OSM had installed two piezometers to monitor the mine pool.

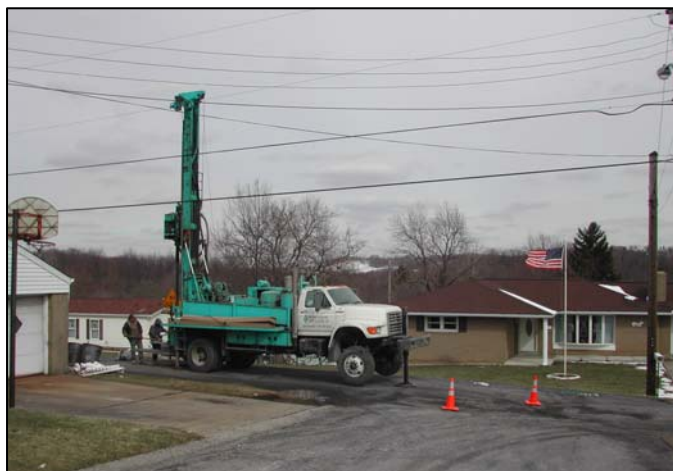
Figure 2. Piezometers installed as part of hydrogeologic investigation. (03/10/05-photo by Rich Beam, BAMR)

the brick streets). Fourteen air-rotary boreholes were drilled by McKay & Gould Drilling (Darlington, PA) with eight piezometers installed into the mine workings (7 in voids) from 03/09 to 03/11/05 in or near the streets of McDonald. (See Fig. 2.) All boreholes and piezometers were located by the BAMR survey crew. On 03/23/05, pumping at the “blowout” was suspended and a 24-Hour Mine Pool Response Test was conducted by BAMR and EIS with water levels measured at specified intervals at the “blowout” and within the piezometers, including two installed by OSM. A map depicting the water level change (0.1 foot contour interval) was constructed to indicate possible areas for relocation of the mine water.

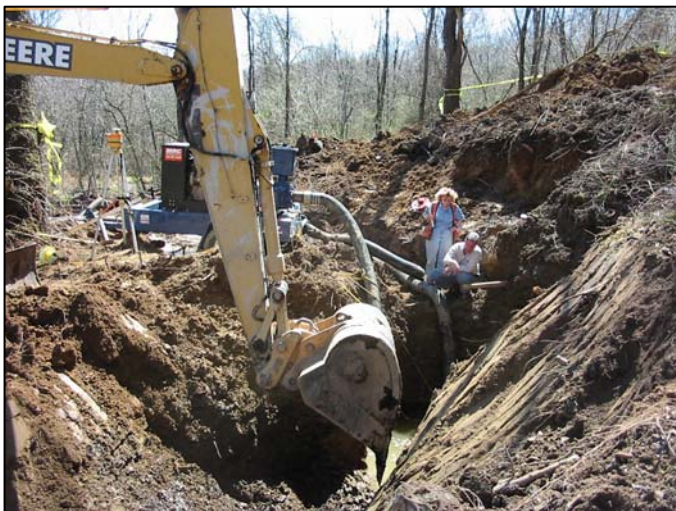
Figure 3. Test pits excavated with pumping conducted to determine favorable locations for Primary and Secondary Drains. (04/08/05)

pumping was conducted and then a temporary gravity drain was installed at Test Pit 1. Subsequent monitoring of the piezometers, Test Pit 2 and the “blowout”, indicated successful control of the elevation of the mine pool at the “blowout”. (See Fig. 3.) Monitoring on 04/09/06 through 04/13/06, a period without precipitation events, indicated that the elevation at Test Pit 1 needed to be maintained about 1½’ lower than the target elevation at the “blowout” during that time period.

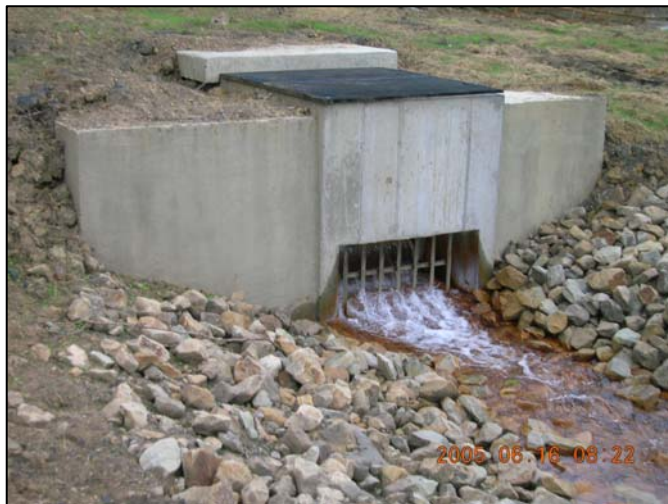
Figure 4. Primary Drain online May 20, 2005. (06/16/05)

At the inlet, flow is intercepted and conveyed by the following three components: (1) three, 8” perforated pipes placed about 26 feet into the mine void, (2) an 18” perforated vertical riser with 18” perforated barrel, and (3) a non-calcareous, R-4, (6” average diameter) rock drain. The vertical riser allows monitoring and access for future pumping, if needed, and is protected by a concrete manhole with a bolted access cover, having a single 1” perforation to allow for manual water level measurements and venting of gases, if present. The inlet area was backfilled with R-4 rock with geotextile fabric used for layer separation of select onsite fill. Where appropriate, the area was graded and revegetated.

At the outlet, a rectangular concrete structure (4’W x 5’H x 13’L) set on two concrete footers with wing-walls to function as “anti-seep” features, includes a “weir-like” water level control feature that facilitates limited mine pool elevation manipulation (maximum ~5’) as well as relatively accurate flow rate estimations. The structure is covered with a concrete lid (6’W x 9’L) to deter unauthorized entry. Locking and hinged grating was placed immediately above the weir

for access to manipulate the mine pool, if needed, as well as continued monitoring. A stilling well with datalogger facilitates water level measurements and a riprap-lined (R-4) channel conveys the discharge to a previously degraded stream. (See Fig. 4.)

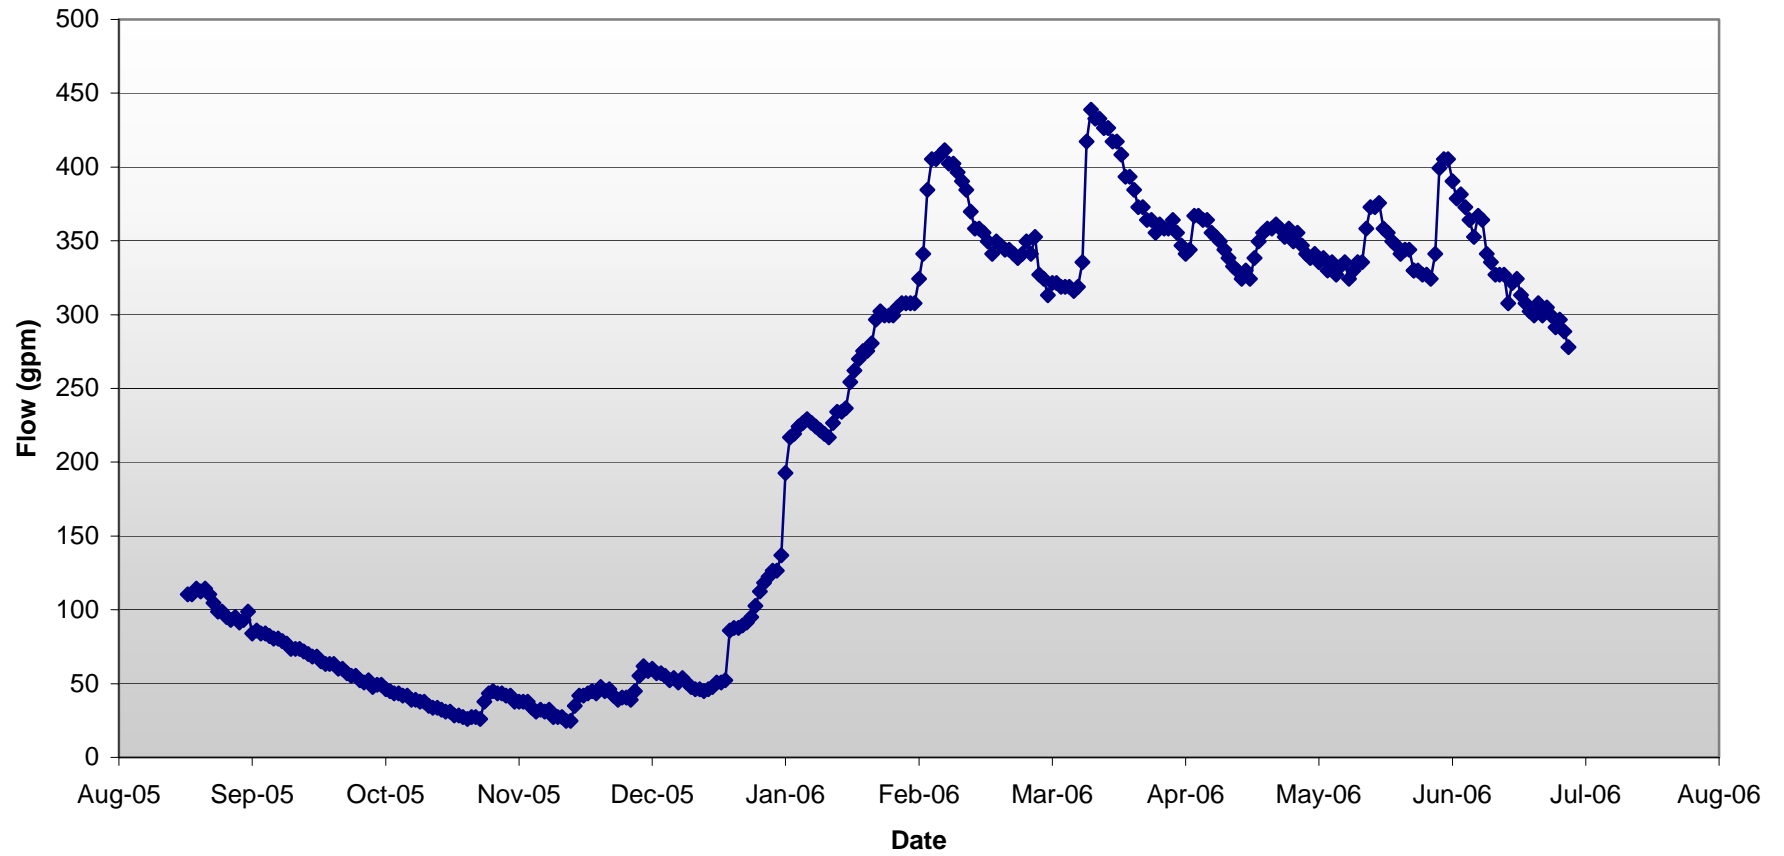
Figure 5. Primary Drain Discharge Monitoring

The weir notch was cut into ½" Tivar installed on the upstream face of stainless-steel stoplogs, and, by using the 1,000-gpm design flow and calculated required head for the targeted mine pool elevation at 1046.2 feet at the "blowout", the crest of the weir was set at 1044.5 feet. (Note: With insertion of all stoplogs, the crest of the weir would be about 1047.5' feet. The Secondary Drain with an overflow pipe invert at about 1048' would discharge prior to draining at the "blowout".) The weir has a total maximum measurable depth of 1.3' for a maximum measurable flow rate of ~6,000 gpm. Flows in excess will be above the weir and additional calculations would be needed to estimate flow rate. Monitoring of the flow rate at the Primary Drain is ongoing. Figure 5 depicts the variations in flow rates.

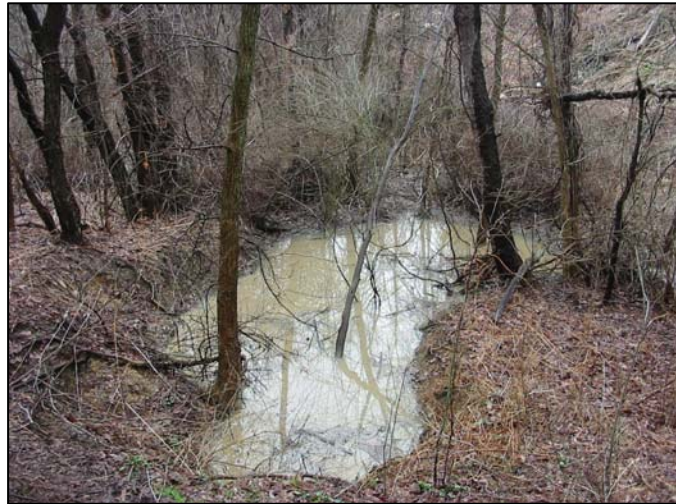
Design. The Secondary Drain, constructed in Test Pit 3 which was located in a subsidence depression that actively conveyed surface water into the mine, not only allows access for monitoring of the mine pool and for future pumping, if needed, but also provides an outlet for mine pool drainage should the Primary Drain be compromised or other significant hydrologic changes occur within the mine. The top of the riser is protected by a concrete manhole with

Figure 6. Subsidence depression intercepting "Miller Run" prior to Test Pit 3 excavation. (03/03/05)

an access cover secured by bolts. The cover has a single 1" perforation at the center to allow manual water level measurements and venting of gases, if present. (See Fig. 6.)

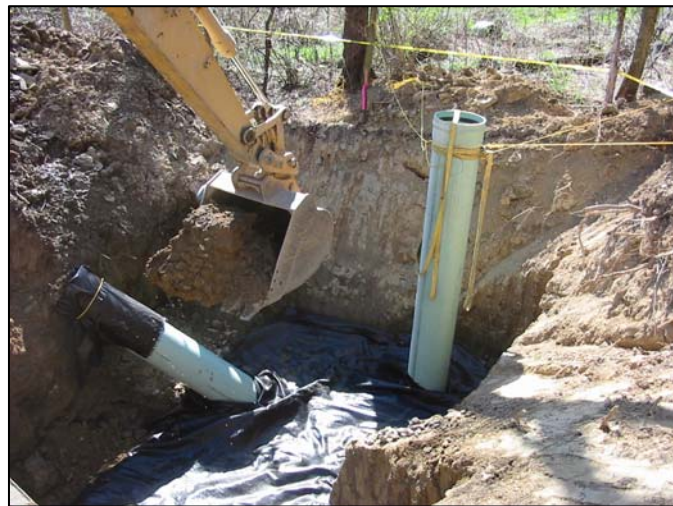
Figure 7. Construction of Secondary Drain. Geotextile used for layer separation of aggregate and backfill. (04/13/05)

An 18" riser pipe diameter was selected in order to facilitate a typical intake basket (~12 inches in diameter) for an 8" diesel pump suction line and to allow a reasonable annulus for flow within the riser. An 18" overflow pipe was included in the design to provide a "safety relief" for the mine pool. From a 45° WYE installed near the bottom of the riser, the 18" overflow pipe with 45° elbow was then installed in order to direct overflow to a constructed channel and eventually to "Miller Run", a stream historically degraded by AMD. (See Fig. 7.)

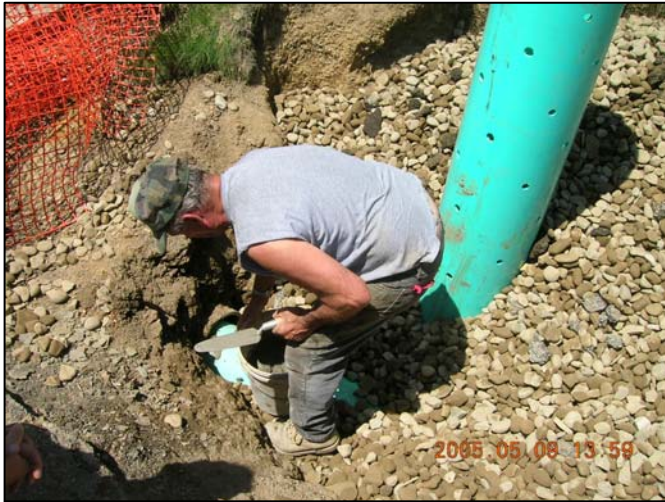
Figure 8. Local resident and subcontractor Dave Menke assists in the installation of the Early Warning System at the "blowout". (05/09/05)

This component allows for continued monitoring (datalogger installed) of the mine pool elevation at the "blowout" location, as well as an additional "safety relief" point that will discharge in the unlikely event that the mine pool elevation rises to ground level. The "blowout" was cleaned to the maximum extent practicable with a rubber-tired backhoe. A 15" SDR35 riser, with 1" and 1<sup>1/8</sup>" perforations (about 50% of each) on 6" centers spaced both vertically and horizontally, was set into the void. A short section (~6'L) of 6" SDR35 pipe perforated with five 5/8" holes every 6" was inserted "back into" the mine void as feasible and connected to the 15" riser below design water elevation. PADOT #3, non-calcareous, aggregate was placed around the pipe to the level of the bottom of the sidewalk. The top of the riser is protected with a cast-iron manhole access cover set in concrete with bolted lid. The lid was perforated with seven 1" holes to allow manual water level measurements. In addition to monitoring, this perforated cover will allow water to discharge in a highly visible area of a residential section of McDonald Borough. If this were to occur, the

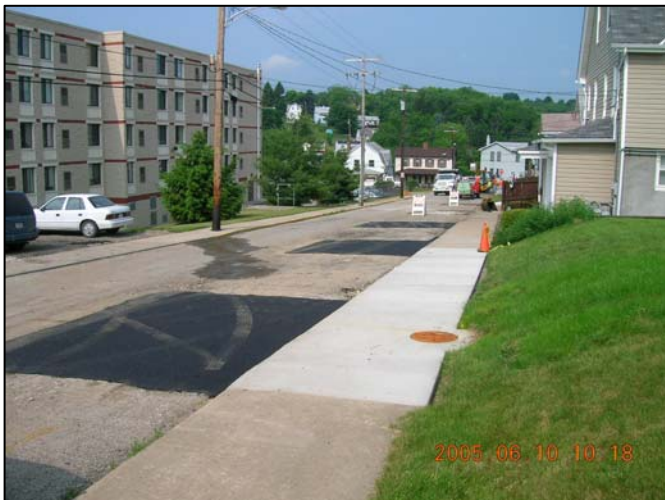
Figure 9. View of the manhole cover of the Early Warning System in the repaired sidewalk. (06/10/05)

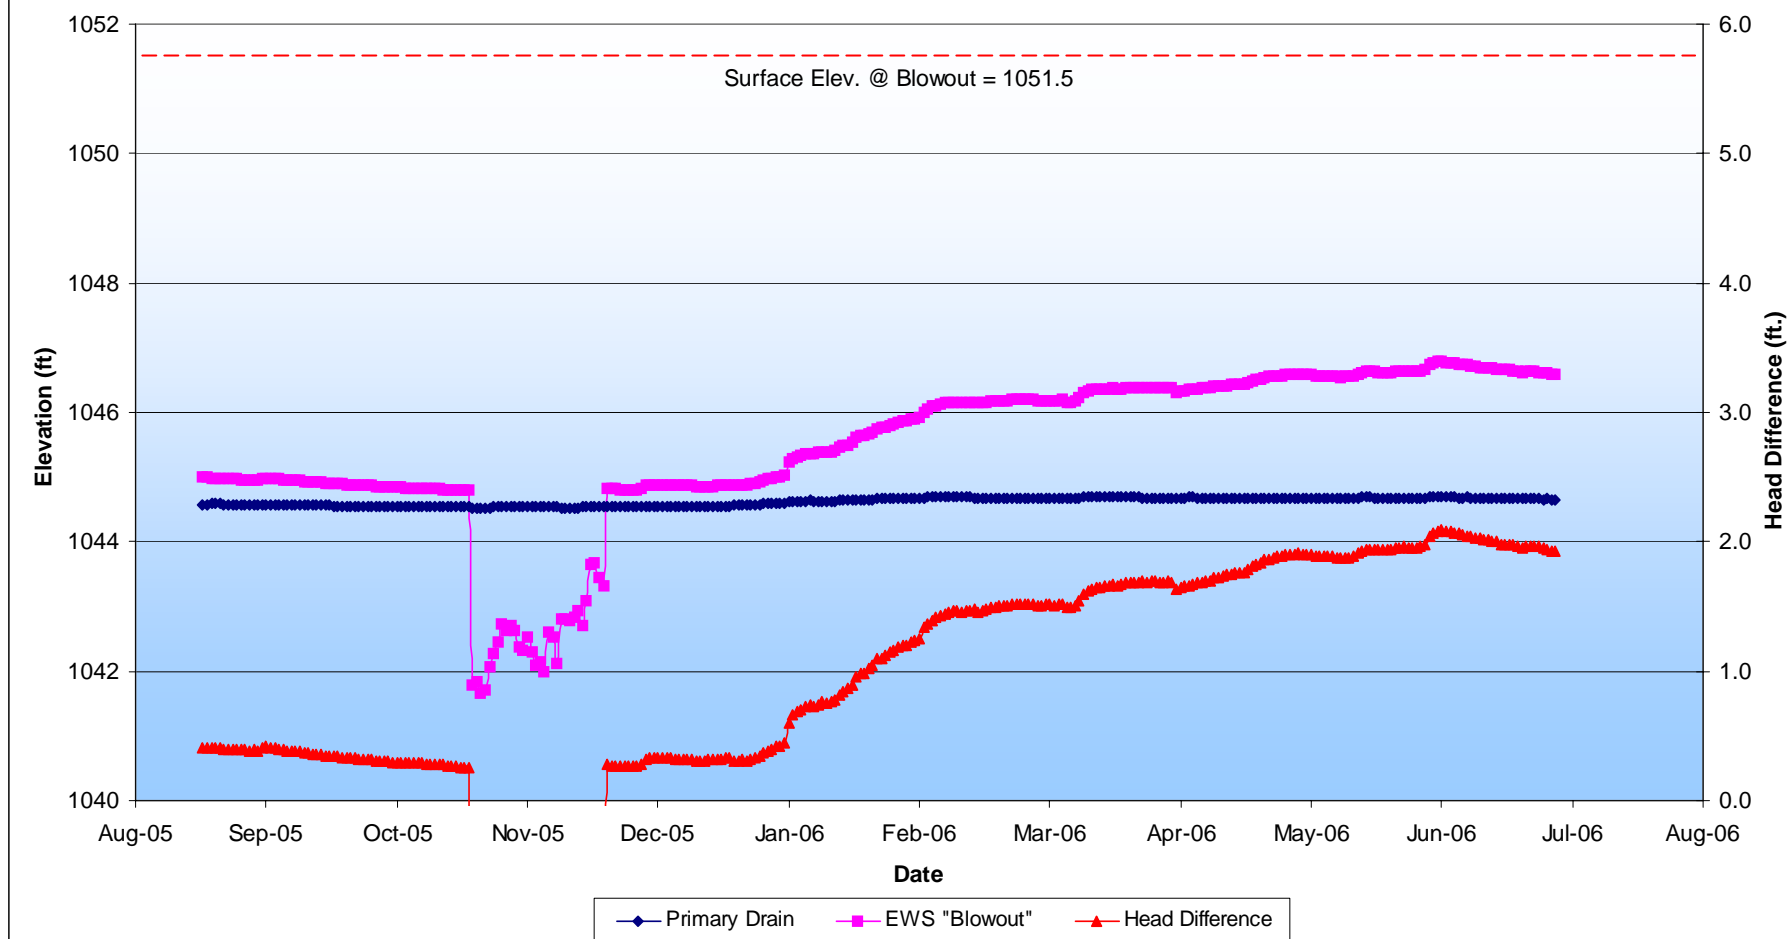
Figure 10. McDonald Mine Pool Elevation Monitoring

The cause of the “blowout” at McDonald is unknown; however, Hurricane Ivan (09/2004) is expected to have been an influence. More than a year after implementation, all systems appear to be functioning. (See Fig. 10.) The cost for project completion under the BAMR contract, including compilation of historic data, installation of piezometers, mine pool response tests, community outreach, and “design-build” of facilities was about \$400,000. Monitoring by BAMR is continuing. To date, no maintenance has been required at the Primary Drain or the “blowout”. The only maintenance was the removal of sediment (shoveled by hand) washed from upland areas that had accumulated at the pipe outlet of the Secondary Drain in 06/2006. Passive treatment is planned for the abandoned mine discharge in 2007/2008.
